Final
Report

March 1972

Composite Overwrapped Metallic Tanks

MARTIN MARIETTA CORPORATION

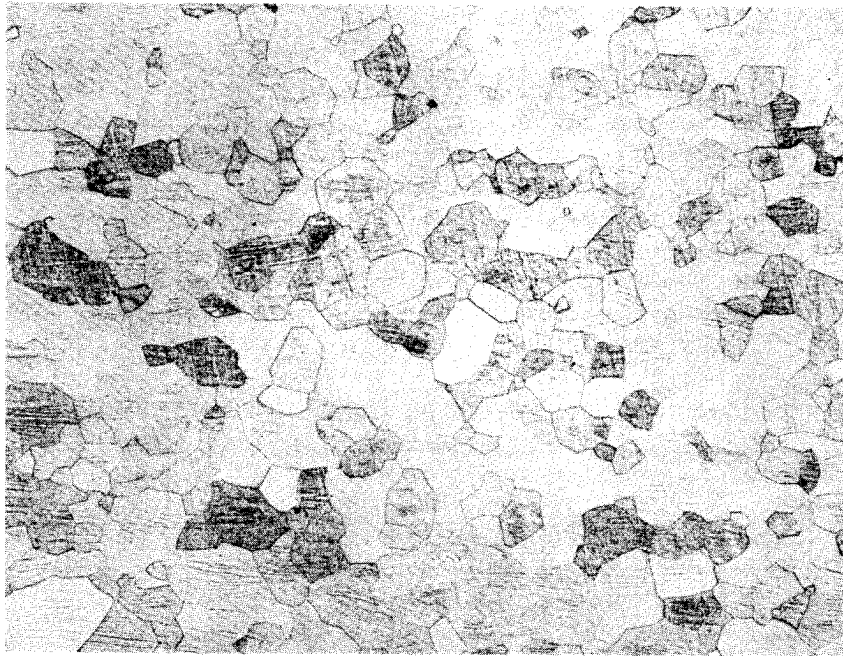
Figure 10 Photomicrograph of Properly Annealed
Ti-5Al-2.5Sn (ELI)

A metallurgical investigation as to the cause of failures was then undertaken. The normal cause for forming failures in titanium (a hard face-oxidized surface and contamination) was suspect. Investigation revealed that improper annealing by the producer rather than contamination was the cause. Mill records were studied and it was determined that one group of the plates had been annealed at 1500°F for 30 minutes and the second group at 1500°F for 15 minutes. While normal tensile tests did not reveal the lack of a proper anneal, the photomicrographs left no doubt as to the material condition. Photomicrographs (Fig. 7 and 8) show the heavily textured grain structure with no indication of alpha surface scale. All the formed domes listed in Tables 1 and 2 exhibited crosshatched microcracks (Fig. 9). The crosshatched microstructure automatically scrapped all domes that had been produced to this point even though they did not indicate conditions of surface cracking. The normal equiaxial grain structure for this alloy is shown in Figure 10.

Attempts to return the material to the producers were fruitless and, since replacement appeared out of the question, it was determined that a proper annealing cycle must be developed to salvage the remaining material. This was accomplished, and a period of four hours at 1650°F in a vacuum followed by a furnace-cool proved to be the optimum cycle. The full report of the failure analysis and supporting technical data may be found in the appendix. The ABAR vacuum furnace at the Denver Division facility was not large enough to economically anneal the blanks. The only other suitable, certified vacuum furnace in the area was located some 60 miles away in Colorado Springs at the Proto Shop. This furnace, an Ipsen, contained automatic controls, proper temperature and pressure readouts, and recording equipment. After thoroughly discussing the problem, arrangements were made with the very cooperative Proto Shop management to give the titanium annealing effort first priority. A maximum effort to properly anneal the material for explosive forming and to provide "in process" annealing between shots was undertaken. The annealing for the remaining supply of blanks began on April 23 and was completed on May 23. In the meantime, blanks were being given their first explosive-forming shots, process annealing, and second shots, etc, as rapidly as

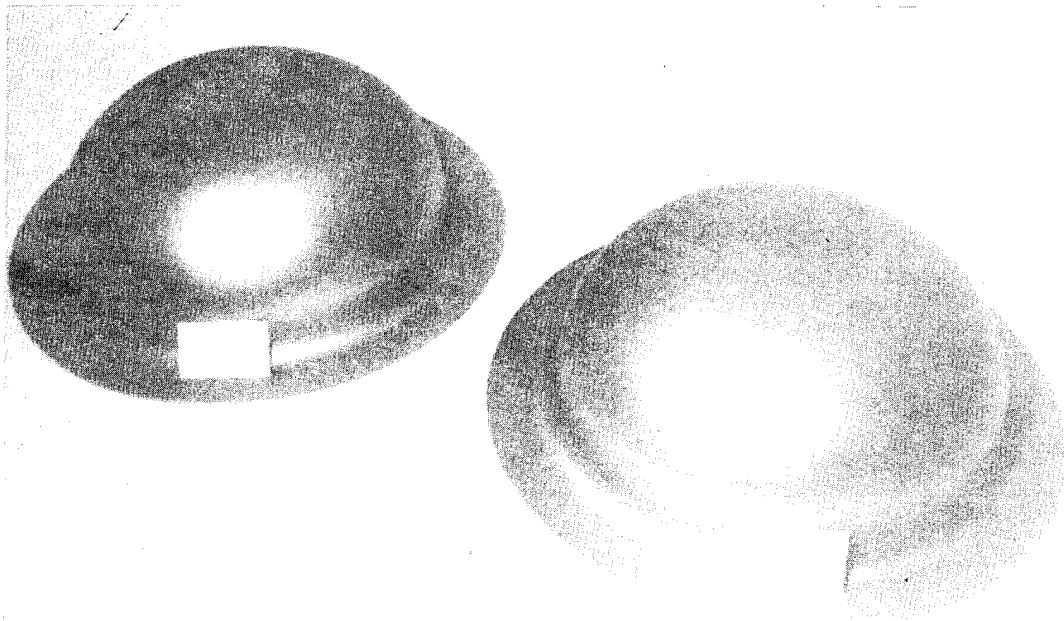
Figure 12 Fully Formed Domes Coated with Turco Pretreat Prior to Annealing in Air Furnace

In general, before and after each dome-forming operation, the dome had to be annealed. The dome was prepared for annealing by chem milling 0.005 inch maximum per surface and coating with Turco Pretreat (Fig. 12) to prevent oxidation. After annealing, the Turco Pretreat was removed by again chem milling the dome. This processing sequence proved successful and no further dome cracking was experienced.

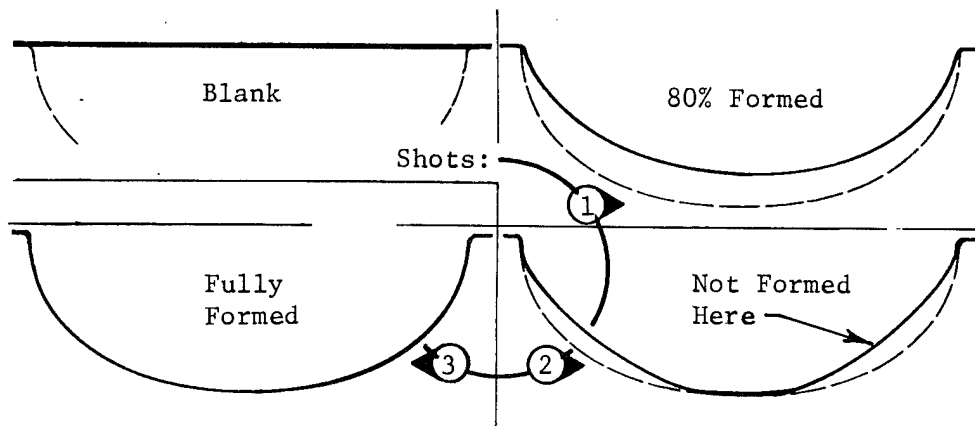
Figure 17 Explosive-Forming Sequence

Raw Material Thickness Deviation: $0.220 \begin{matrix} +0.046 \\ -0.010 \end{matrix}$ in.

Best Deviation from Contour (H-2): $-0.030, +0.050$ in.

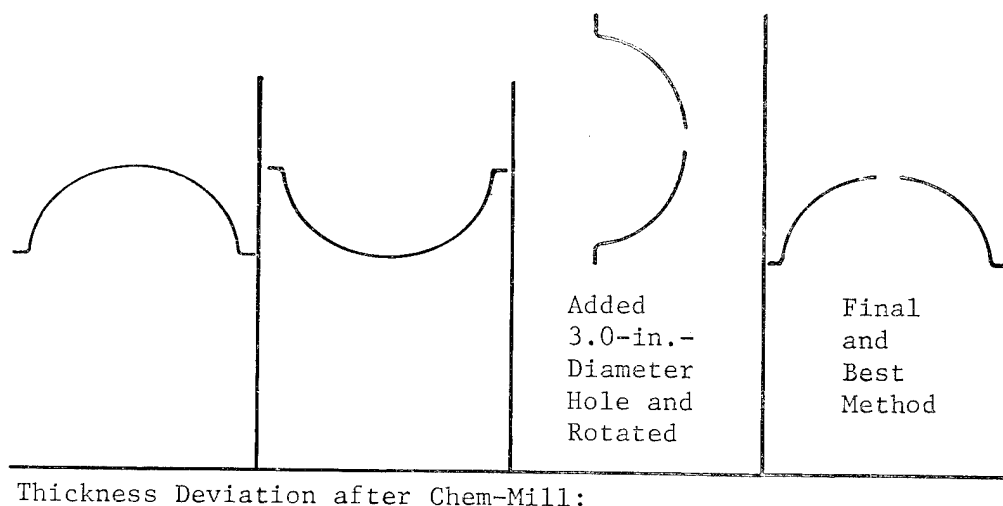
Figure 18 Development of Dome Position in Chem-Mill Tank

Early efforts to optimize chem-milling methods began with a fixture designed and fabricated to hold the dome in a horizontal position. Nonuniform etching was experienced whether the flange was up or down. Discussions pointed out that gas entrapment areas along the contour and at the apex were causing preferential etching. The recommended fix was to create a hole at the dome apex to allow gases to flow along the contour and escape through the hole. This apparently solved the problem, but after a manufacturing personnel change and another schedule delay, an alternative method was tried. The fixture was modified to hold the dome in a vertical position and it became necessary to rotate the dome at closely timed intervals to once again prevent preferential etching. This approach met with fairly good success as long as the chem-mill operator closely controlled the rotation intervals. Although some success was experienced, the process was later revised to holding the dome in the horizontal position. This method was more reliable and produced the best results. Figure 2 shows the dome chem-mill pattern desired and Table 5 reflects a typical actual thickness and contour chart for a single dome. Dome E2 reflected the best chem-mill results with 0.109/0.122 inch in the thin area and 0.154/0.164 inch in the thick area. The worst dome was N1, which had 0.109/0.144 inch in the thin area with 0.127/0.188 inch in the thick area. Figure 18 depicts sequential dome positions developed for best chem-milling results. Figures 19, 20, 21, and 22 illustrate the chemical milling process.

$$\text{Best (E-2)} = \frac{0.109}{0.122} \text{ \& } \frac{0.154}{0.164} \quad \text{Worst (N-1)} = \frac{0.109}{0.144} \text{ \& } \frac{0.127}{0.188}$$

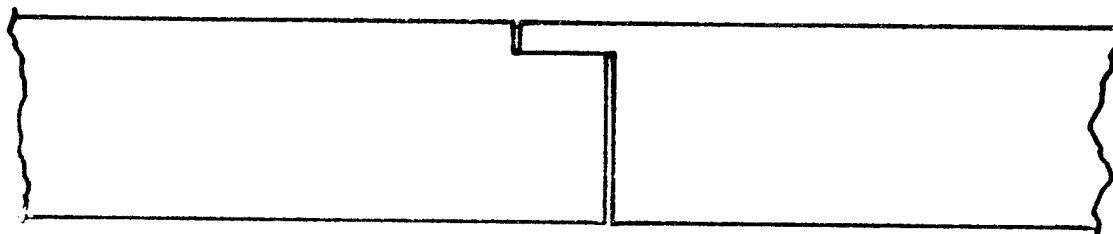
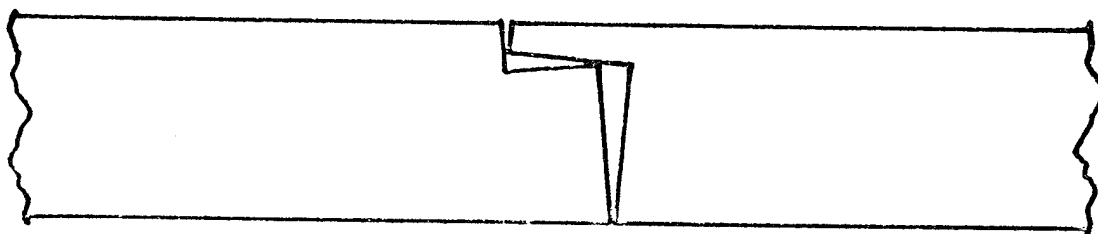
After S/N 1 failed during the hydrostatic sizing operation, a failure analysis uncovered lack of fusion in the girth joint. As a result S/N 2, which had been completed, was returned for rework. Rework consisted of removing both interlocking step joints at the girth. Although a new barrel was used for reassembling the tank liner, some volume was lost due to elimination of the old weld area on both domes. The barrel and domes were prepared for final welding by machining a straight butt joint and tack-welding the barrel and dome together.

Joint Design

As-Assembled Joint

(Poor Fitup due to Machining Tolerances and Dome Out-of-Roundness)

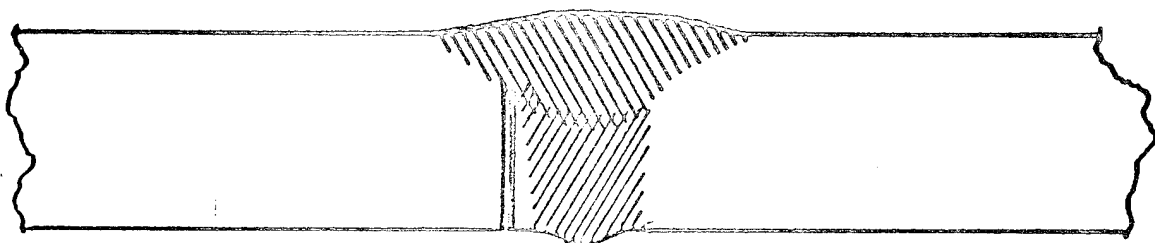
Figure 35 Defective Single-Pass Electron Beam Weld and Proper Triple-Pass Weld

Figure 35 illustrates the lack of fusion on S/N 2 when the single-pass weld technique simply missed the joint. The only thing holding the joint together was the cosmetic pass over the outside for smoothing out the contour. The lower portion of Figure 35 illustrates how the triple-pass weld technique would solve any misalignment encountered. Due to the acceptable results of the tensile tests, the remaining tank liners were joined at the girth with three parallel adjacent welds. No further lack of fusion problems occurred in the girth joints.

Electron Beam Weld Off ϕ of Joint

Triple Pass Plus Cosmetic Pass

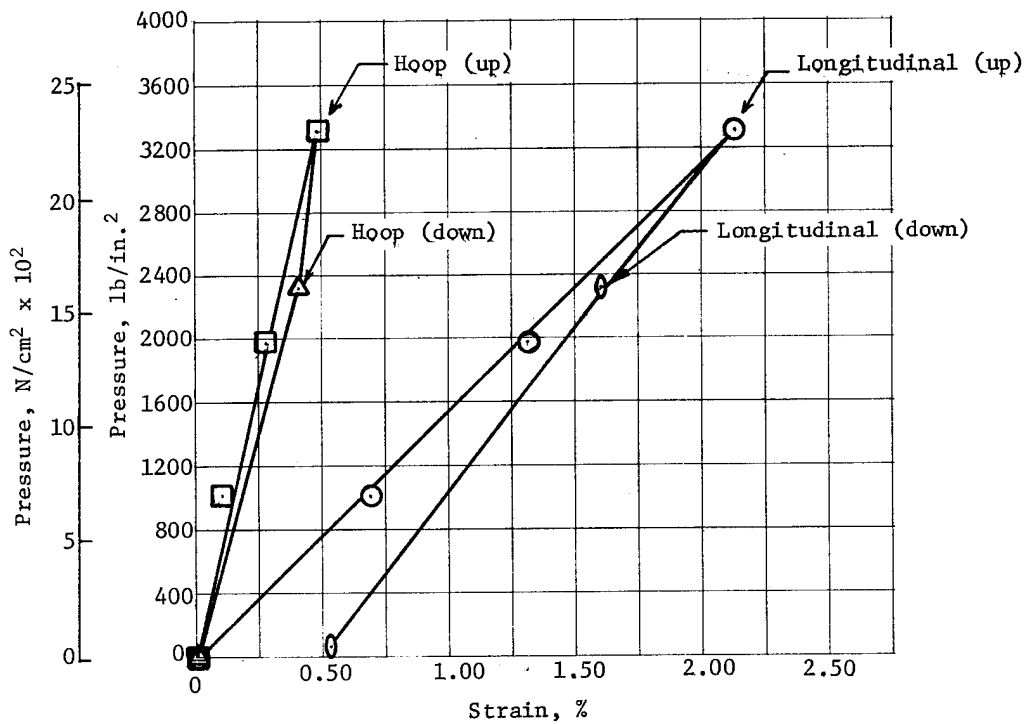
Figure 50 is the strain curve generated in the first cycle pressure test of S/N 6. Succeeding cycles are not plotted since they essentially duplicate the first cycle.

Figure 50 S/N 6 Cycling Test (First Cycle)

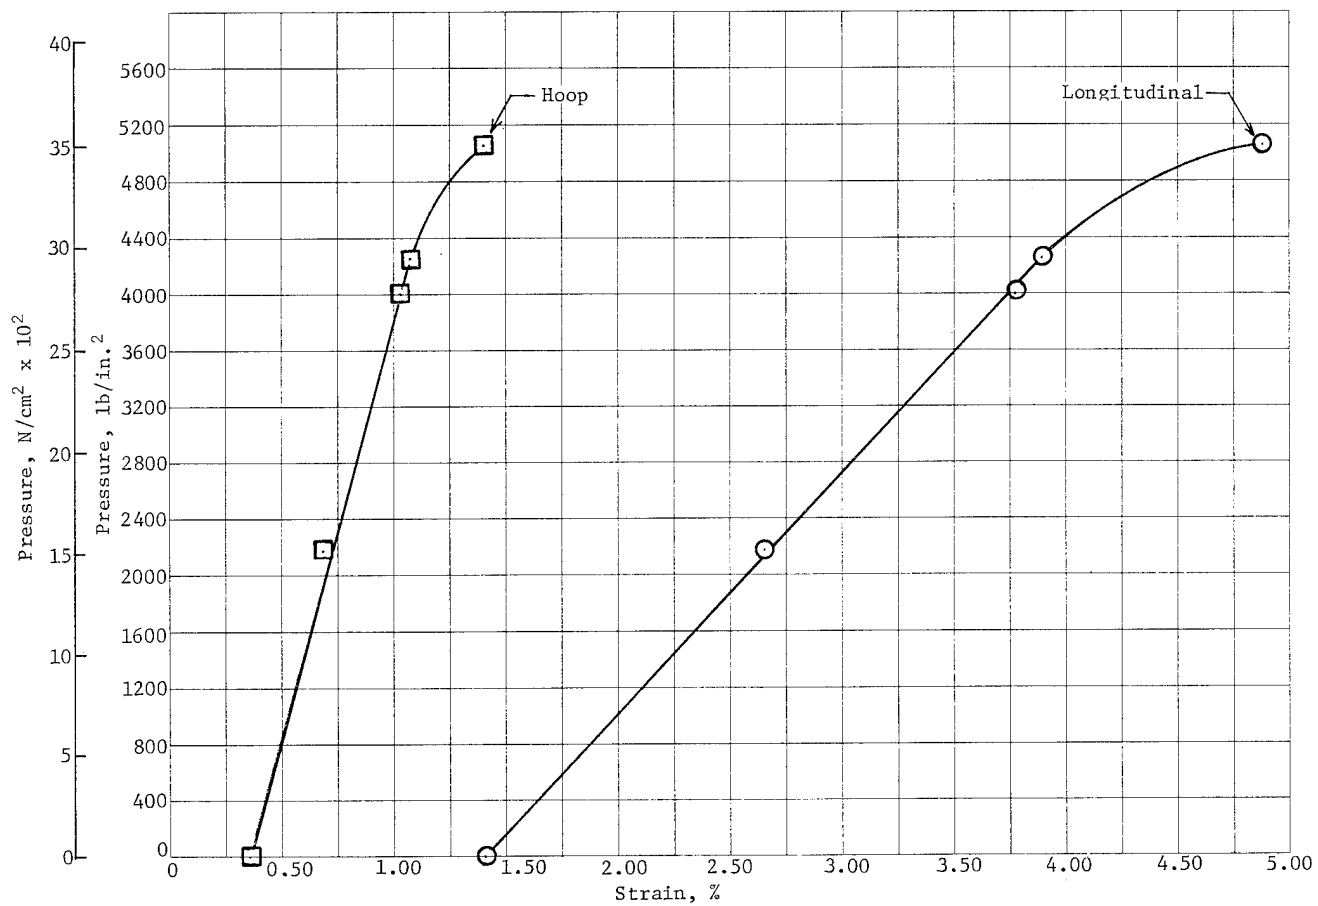
Figure 52 is the strain curve generated during ambient burst test of S/N 7. It is interesting as well as predictable to note that there are residual strains in S/N 7 after it was sized and depressurized. No attempt has been initiated to draw any conclusions from these data because S/N 7 was the only tank tested in this manner.

Figure 52 S/N 7 Burst Test

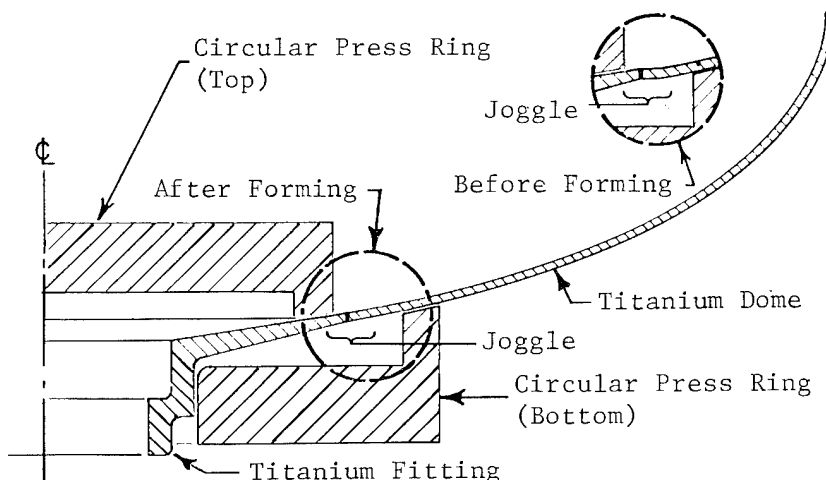
S/N 4 burst at 3854 psi during the hydrostatic sizing operation. This was the first tank that failed outside the girth weld. In this case, the failure was initiated at the dome-to-fitting joint (Fig. 60). The cause of failure appeared to be a combination of a lack of ductility (Fig. 61 and 62) and joint mismatch. The mismatch was not a typical joint misalignment, but appeared to be a condition referred to as "sink-in" brought about as the dome-to-fitting joint shrunk under pressure while cooling after the weldment had been completed. A fix for correcting the "sink-in" effect utilizing hot forming is shown in Figure 63. Refer to Table 12 for the forming process.

Figure 63 Hot-Forming Schematic

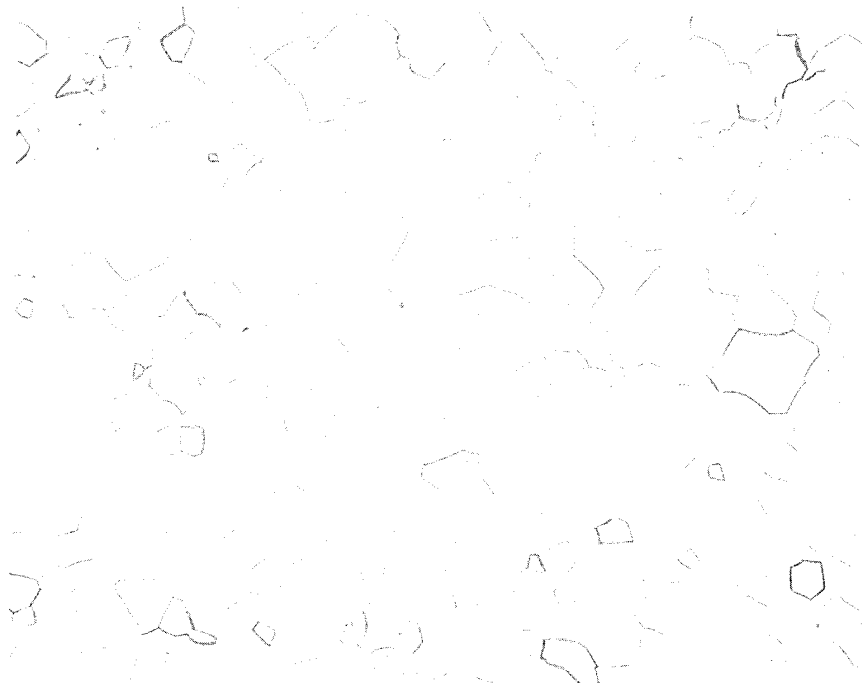
A helium leak check revealed the leak to be in the parent material (Fig. 68 and 69). Dissection of the specimen at the failure point indicates the possibility of stress corrosion (Fig. 70 and 71). In addition, the microstructure near the failure point appears to have a grain boundary precipitant typical of overannealing or overheating. Figures 72 and 73 show comparisons of normal "clean" microstructure versus the "dirty" microstructure near the failure point.

Figure 72 Photomicrograph of Normal "Clean"
Microstructure (100X)

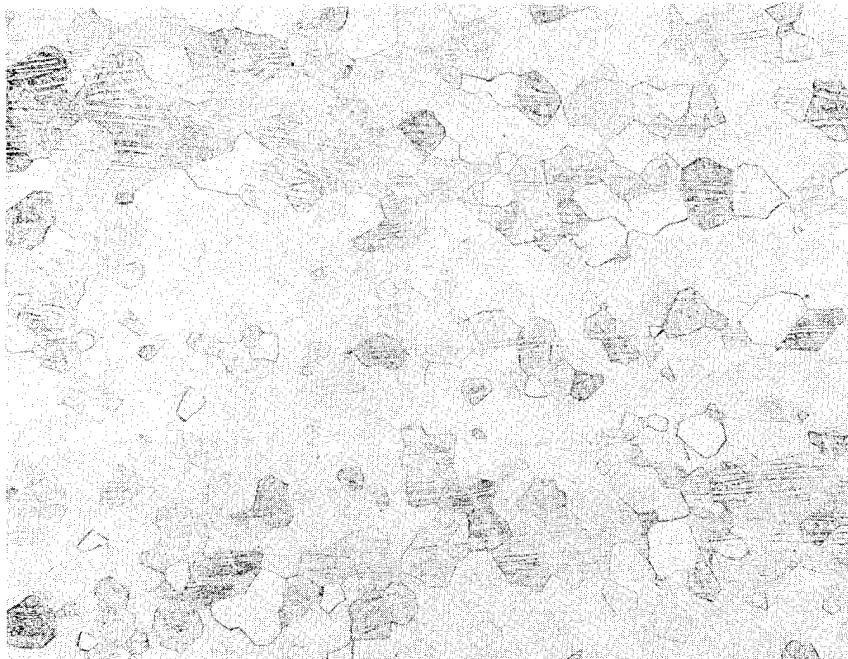
Figure 15 Photomicrograph of Longitudinal Cross
Section at 100X of C Plate Annealed
4 hours at 1660°F

Time, hr	Ftu, ksi	Fty, ksi	%e, 2 in.	Micro
1	117.9	114.2	16.3	Fig. 13
2	116.6	114.1	16.8	Fig. 14
4	116.0	114.0	17.5	Fig. 15
8	115.9	113.9	15.0	Fig. 16
24	113.5	110.6	13.5	Fig. 17
